**POWERPLANTS GROUP FIELD NOTES  
NACELLE & ENGINE  
TEGUCIGALPA, HONDURAS**

**A. ACCIDENT**

Location: Tegucigalpa, Honduras  
Date: May 30, 2008  
Aircraft: Airbus 320-233, Registration Number EI-TAF  
Powerplants Two International Aero Engines V2527-A5

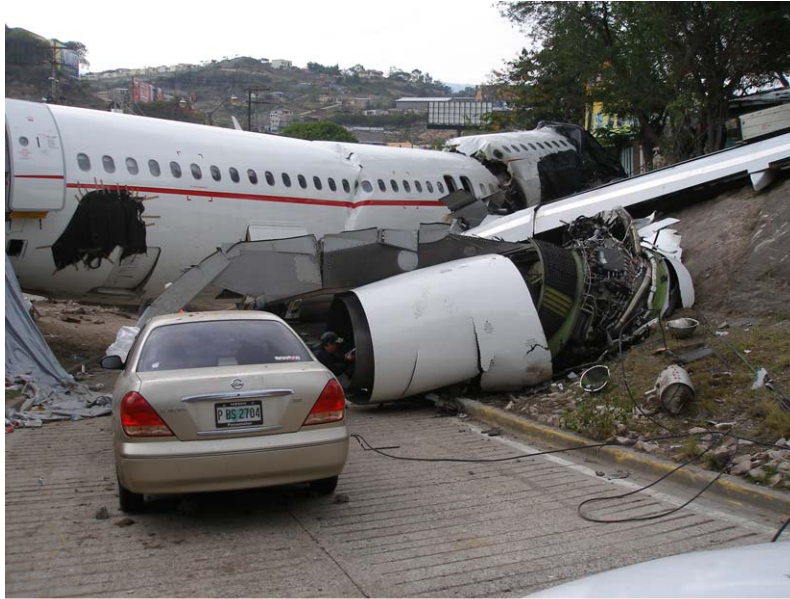
A review of the right hand engine's nacelle ([Figure 1](#)) revealed no indications of an external (under cowl) fire. There were no indications of an uncontained engine event.

Figure 1 – Right Hand Powerplant

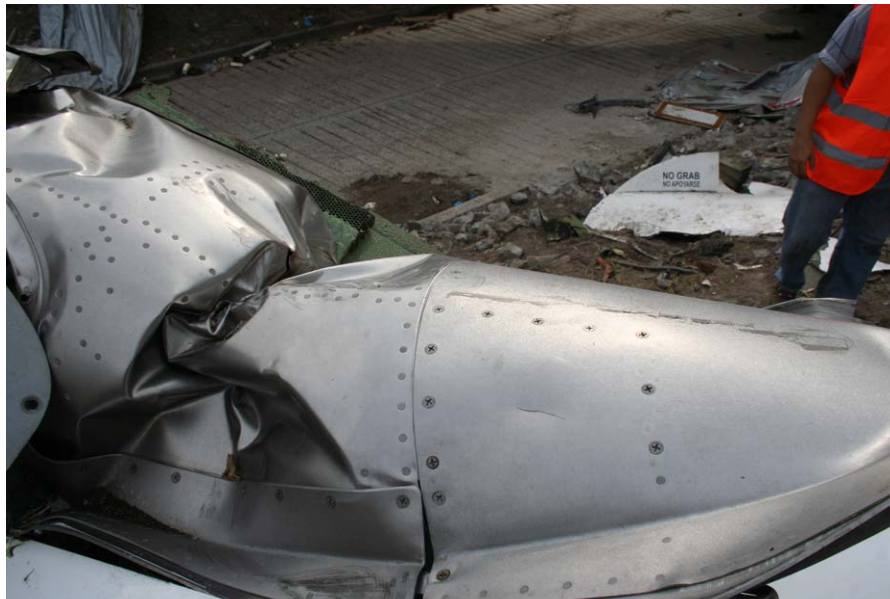
The pylon strut leading edge fairing was buckled and collapsed. There was evidence of contact with wire from a power line ([Figure 2](#)).

Figure 2 – Right hand pylon leading edge

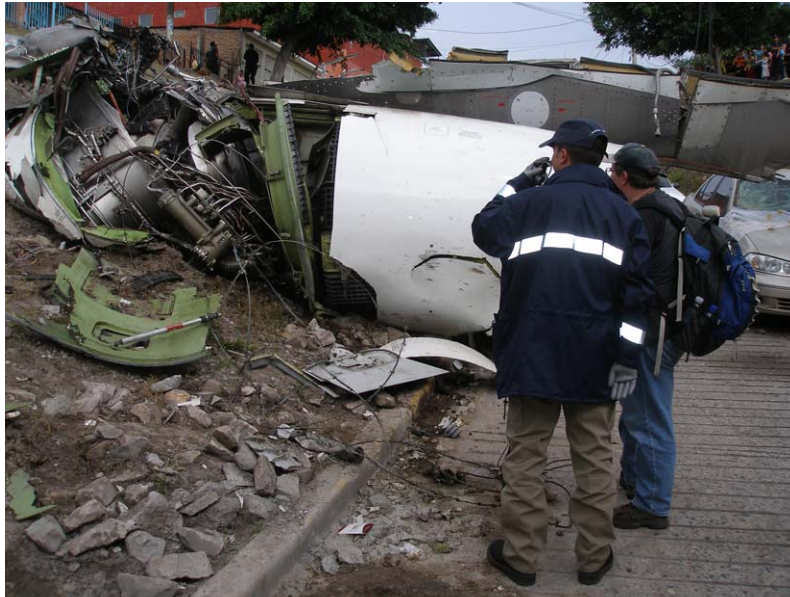
All of the outer fan bypass duct hardware was displaced in a lozenge fashion towards the front and fractured (Figure 3). The engine fan exit case was fractured and buckled inward and forward along the upper quadrant.

Figure 3 – Right hand powerplant

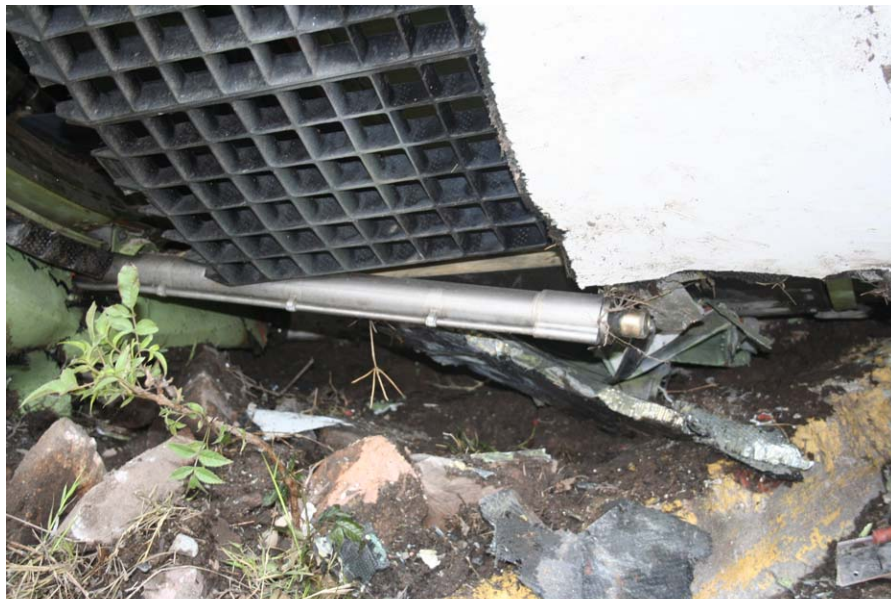
All four thrust reverser actuators were identified (Figure 4). The eye end assembly that connected to the translating cowl structure was not present on any of the four actuators. All four actuators were in the retracted position, consistent with a stowed reverser. The upper right hand side non-locking actuator was disconnected from its hydraulic lines and flex shaft. Upon turning the worm gear with a wrench, a piston translated out of the sleeve end.

Figure 4 – Right hand powerplant thrust reverser left side lower locking actuator

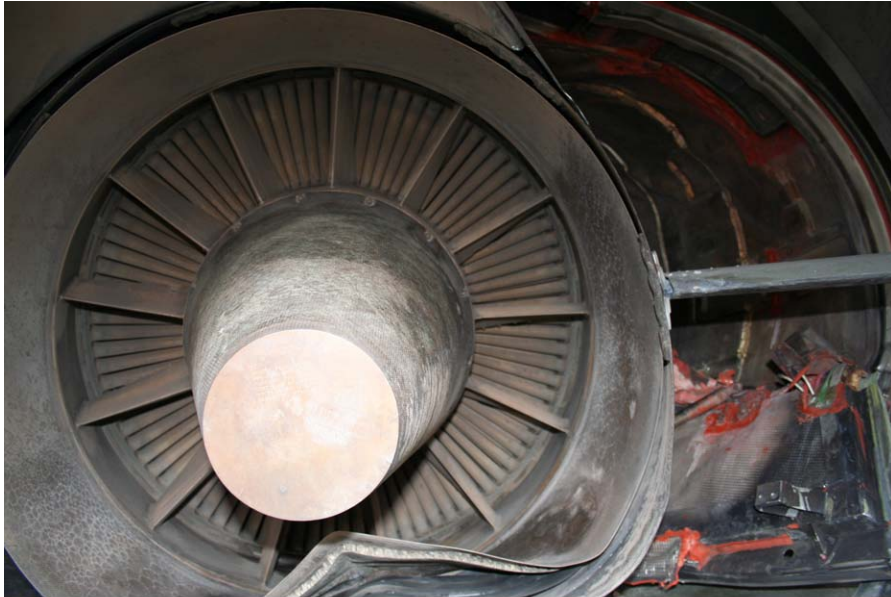
The rear stage turbine blades were all intact, in place and straight (Figure 5).

Figure 5 – Right hand engine rear stage turbine blades

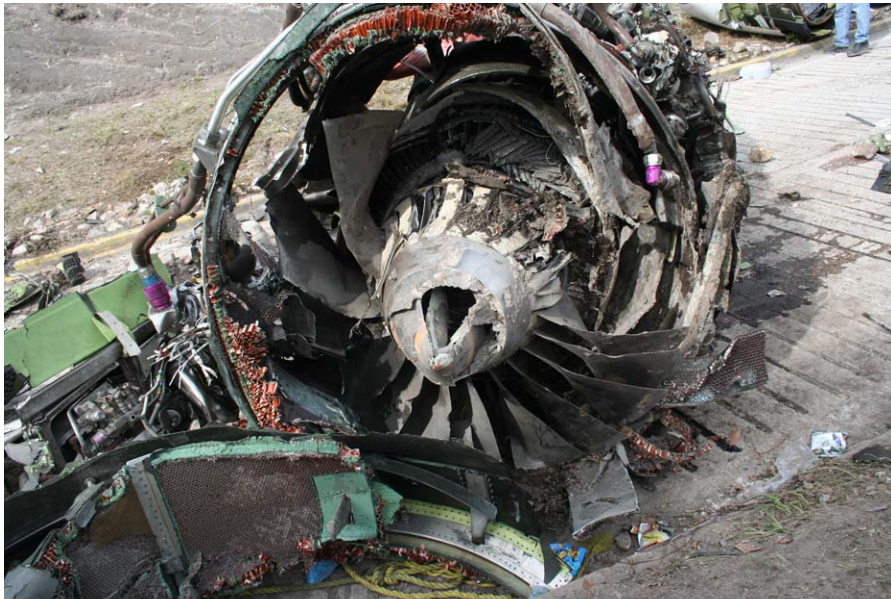
After the removal of the engine from the earthen embankment, the fan blades were observed (Figure 6). The crushed inlet cowl structure and ingested dirt precluded visual inspection of the rest.

From the 6 o'clock to the 12 o'clock position<sup>1</sup> all of the blades were fractured at the inner flowpath plane with the exception of 2 blades, which were severely bent in the direction opposite of rotation. From the 12 o'clock to the 3 o'clock position the airfoil bending was confined to the outer ½ span in the direction opposite of rotation. From the 3 o'clock to the 6 o'clock position the fan blade airfoils outer half spans were deformed in the direction of rotation.

Figure 6 – Right hand engine inlet and fan

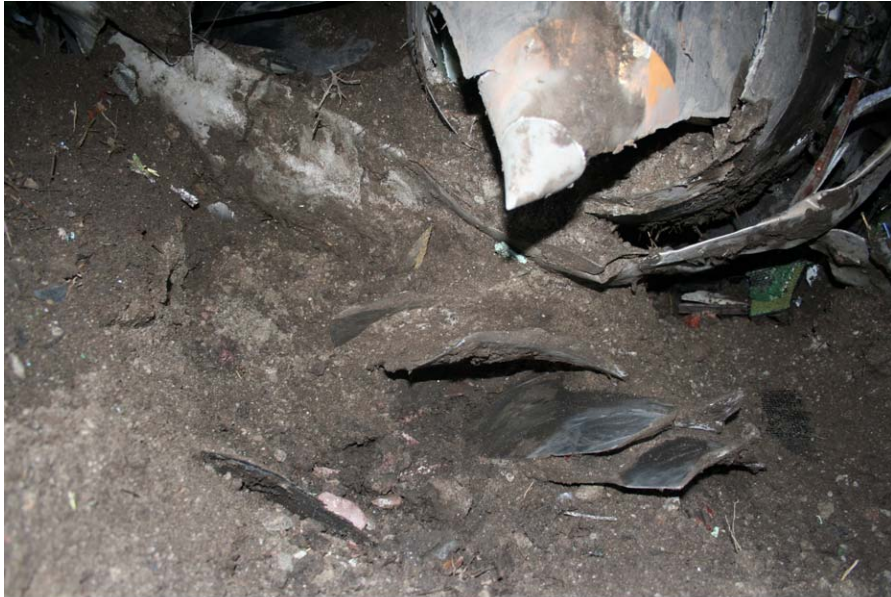
Within the dirt forward of the moved engine at approximately the 6 o'clock position, were 5 fractured fan blade airfoils that exhibited deformation in the direction opposite of rotation (Figure 7). They were also nested together with dirt and remnants of the inlet cowl sandwiched between each blade pair.

Figure 7 – Right hand engine fractured fan blades

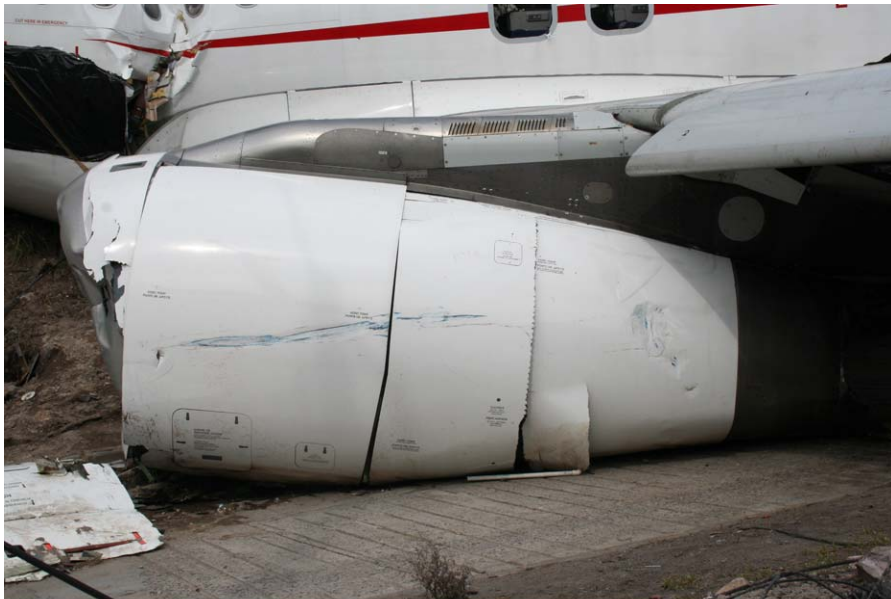
The nacelle was intact (Figure 8) with the exception of the lower half of the right hand fan cowl door. This fractured cowl fragment contained the latches and attached fragments of the left hand fan cowl door. All the latches were intact and still secured.

Figure 8 – Left hand powerplant

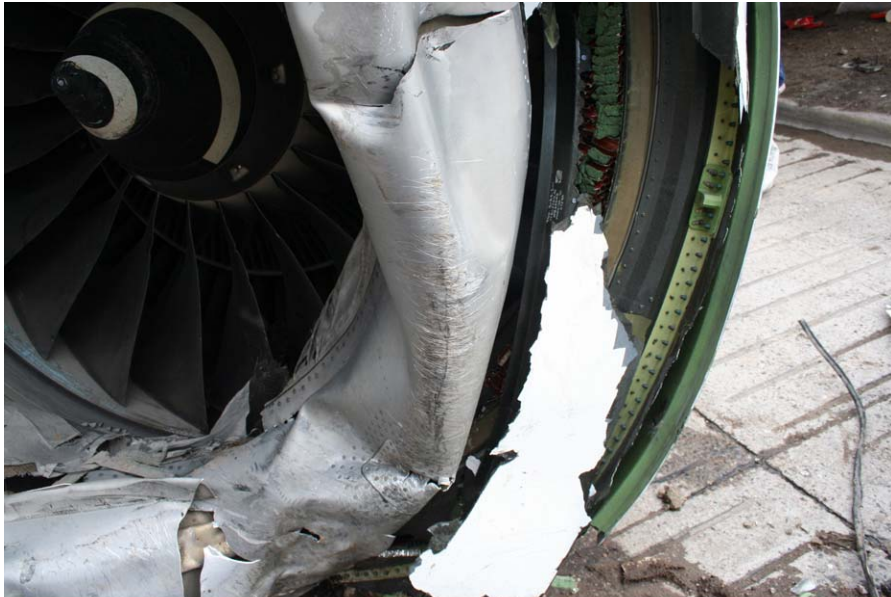
The inlet cowl forward lip had scratch marks (Figure 9) between the 3 and 10 o'clock location consistent with contact against the fencing at the top of the embankment at the end of the runway. The inlet cowl was crushed at the bottom with the crushing damage occurring in an upward and inward direction.

Figure 9 – Left hand inlet lip scratches

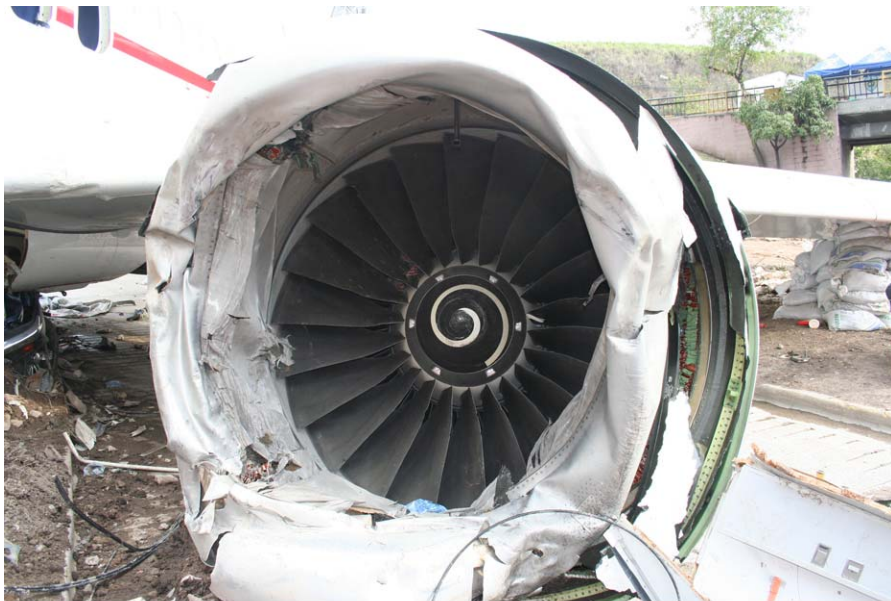
The engine fan blades were intact, in place and straight (Figure 10). All the leading edges exhibited localized deformation; sharp edged tearing and breakout damage consistent with hard object impact (Figure 11).

Figure 10 – Left hand engine fan

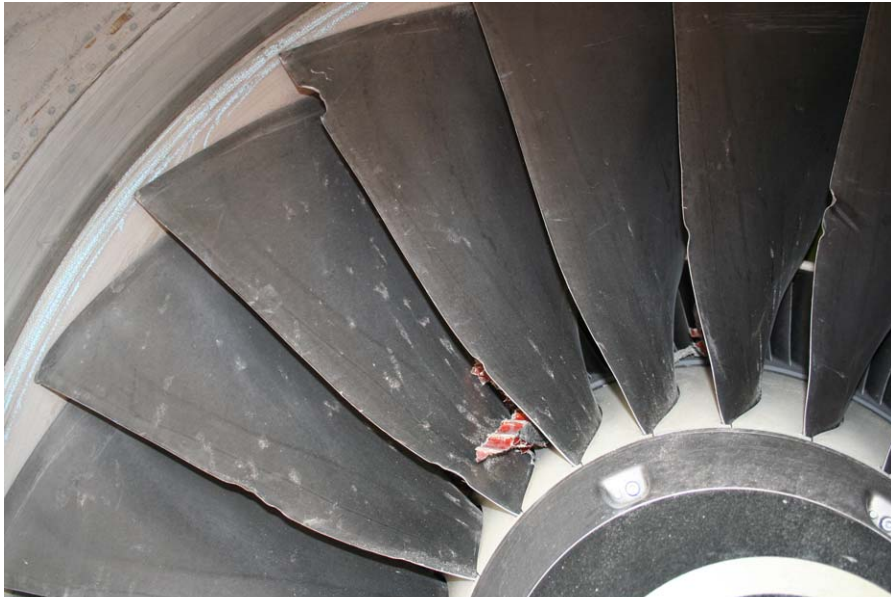
Figure 11 – Left hand engine fan blades details

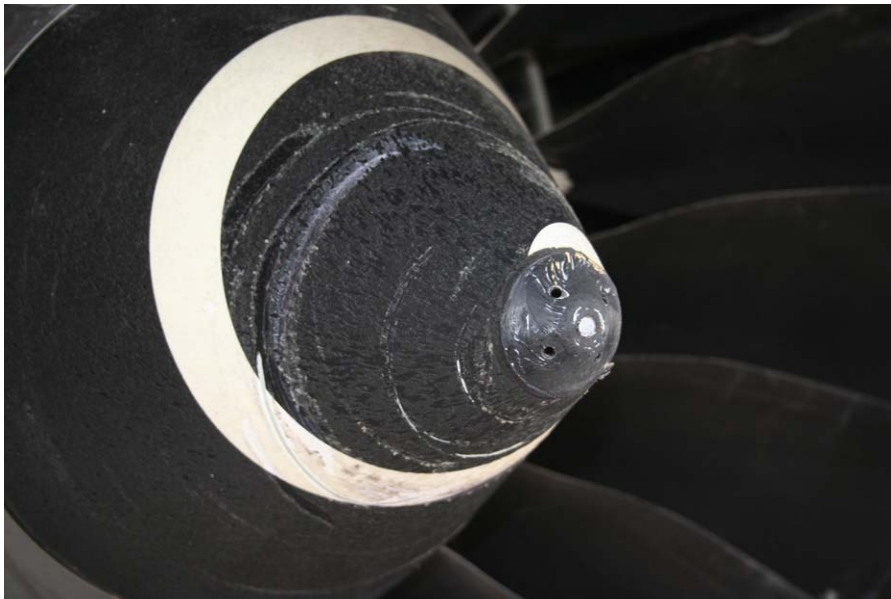
The spinner (Figure 12) had multiple score marks along the forward half of the cone that had spiral characteristics.

Figure 12 – Left hand engine spinner

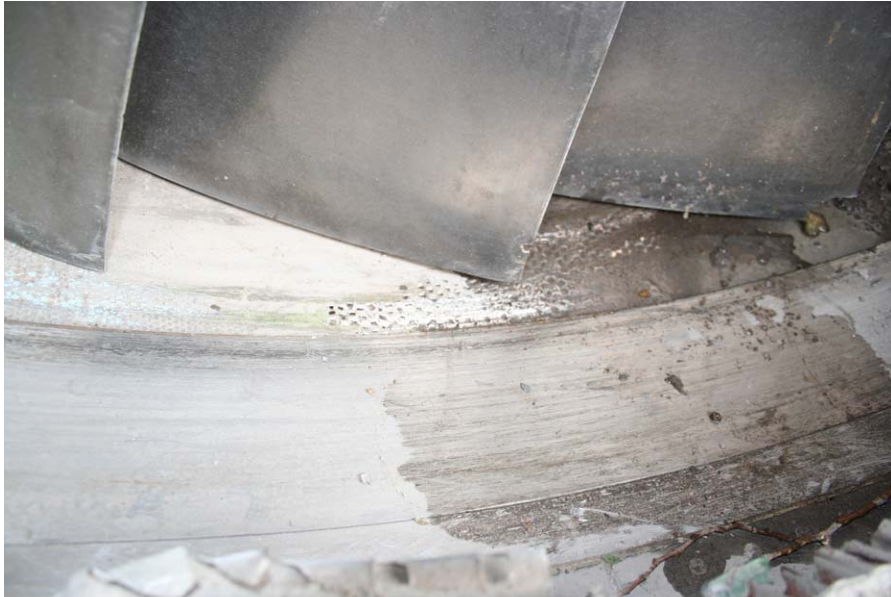
There was a fresh rub on the fan rub strip featuring heavy gouging and rotational scoring. These marks were predominantly on the forward 2-½ inches of the fan rub strip. The 'Blue-Goo' portion of the rub strip was fully penetrated at the 5:30 to 6:30 location of the fan strip with the cell structure of the underlying honeycomb visible (Figure 13).

Figure 13 – Left hand engine fan rub strip at 6 o'clock position

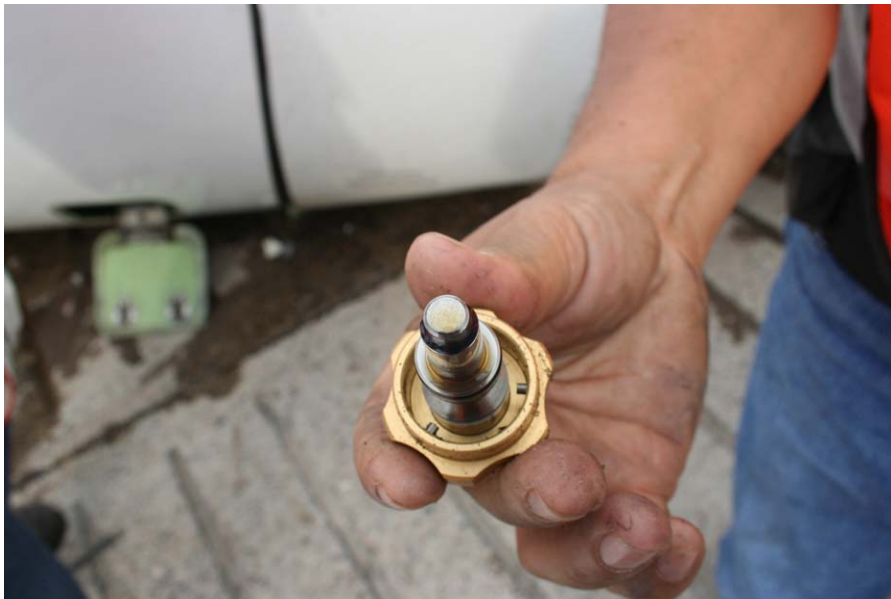
The master chip detector was removed, inspected and found to be clean (Figure 14).

Figure 14 – Left hand engine main chip detector
